# STOP THE ROT

## Report II: Rapid corrosion of handpumps

ACTION RESEARCH ON HANDPUMP COMPONENT QUALITY AND CORROSION IN SUB-SAHARAN AFRICA

Dr Kerstin Danert

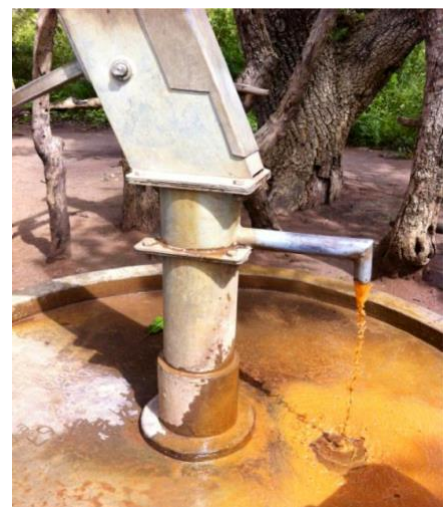
The high turbidity of the water from a corroding handpump that has not been used for some time (e.g. overnight) can be caused by the accumulation of corrosion products. Discolouration of the water to red/brown a few minutes or hours after pumping is due to the transformation of ferrous iron to iron hydroxides and iron oxides when exposed to oxygen in the air. User perceptions of taste, smell and appearance (especially if the water is red after the handpump has not been operated for some time, or if the colour of the water clears after minutes or hours of pumping), changes in turbidity over time (i.e. deterioration over weeks and months), and pumped clear water that turns red after some time are all indicators of handpump corrosion.

**FIGURE 4 RED, IRON-RICH WATER BEING PUMPED**

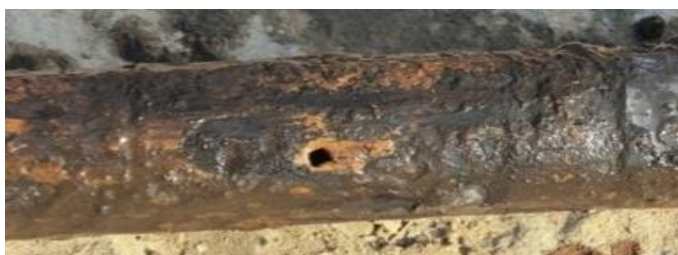
Once corrosion causes holes in the pipe such as pitting (Figure 5a, 5b and 6a), gaping holes (Figure 6c) or damaged threads (Figure 6d), the pipes start to leak. As a result, water flow is reduced (or completely eliminated) and handpump performance reduces. More effort is required in terms of pumping to draw up water from underground. Leakage from the riser pipes also means that it takes longer to prime the pump for use after it has not been used for some time (WaterAid, 2021). Corrosion of riser pipes and pump rods can also lead to outright failure, including riser pipes dropping into the borehole due to damaged threads (Figure 6d).

(a) Riser pipe corrosion in Zambia  
Source: SOMAP3, 2013.

**FIGURE 5 PITTED RISER PIPES FROM CORROSION IN ZAMBIA AND NIGERIA**

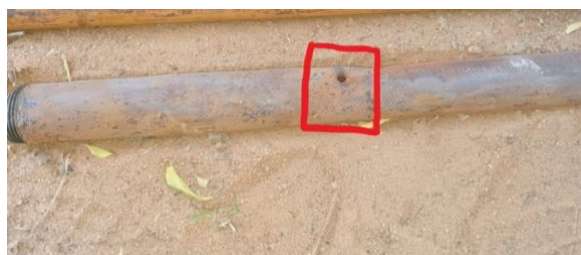
(b) Riser pipe corrosion in Nigeria  
Source: Olajide Oyetunde.

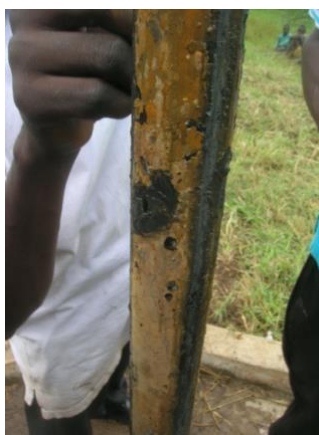
(a) Removal of pitted pipes within, Hoima District, Uganda, 2012  
Source: Larry Bentley.

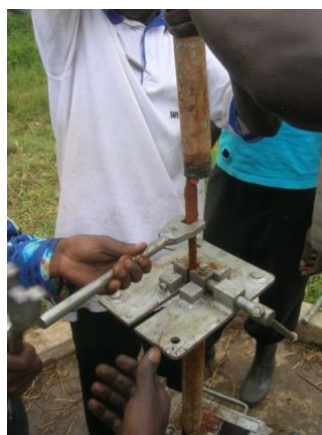
(b) Removal of corroded pump rods and riser pipes in Hoima District, Uganda, 2012  
Source: Larry Bentley.

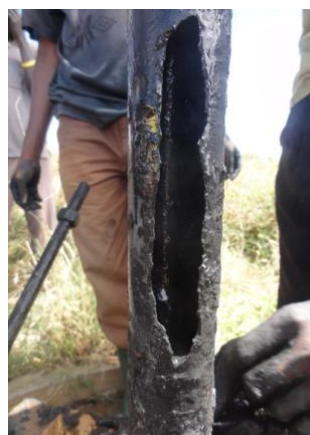
(c) Removal of corroded pipes  
Source: Richard Carter.

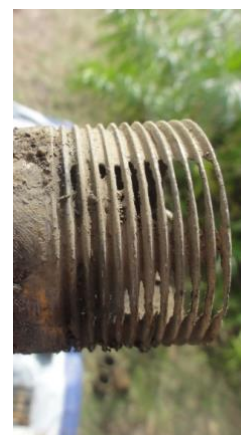
(d) Corroded pipe thread  
Source: Richard Carter.

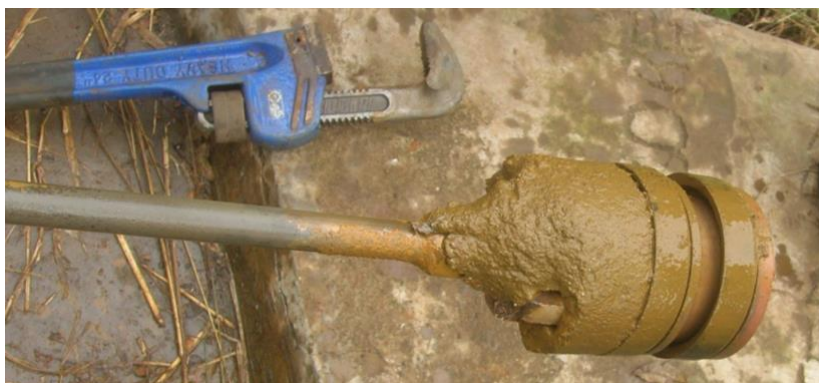
**FIGURE 7 FOOT VALVE COVERED WITH DEBRIS FROM CORROSION**  
Source: Larry Bentley.

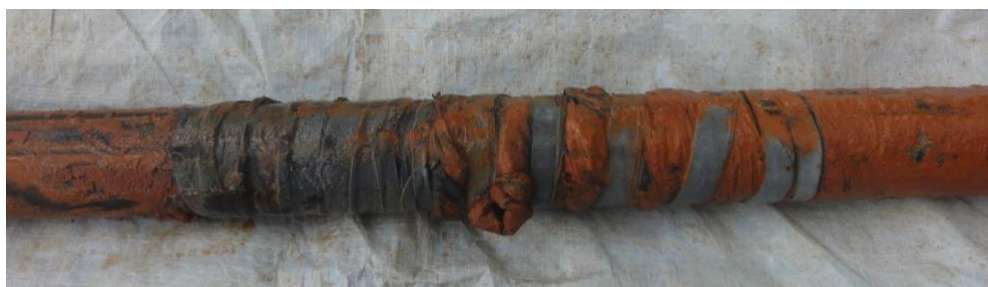
**FIGURE 8 CORRODED RISER PIPE WITH BIOFILM AND REPAIRS USING AN INNER TUBE IN AMURIA, UGANDA**  
Source: Richard Carter.

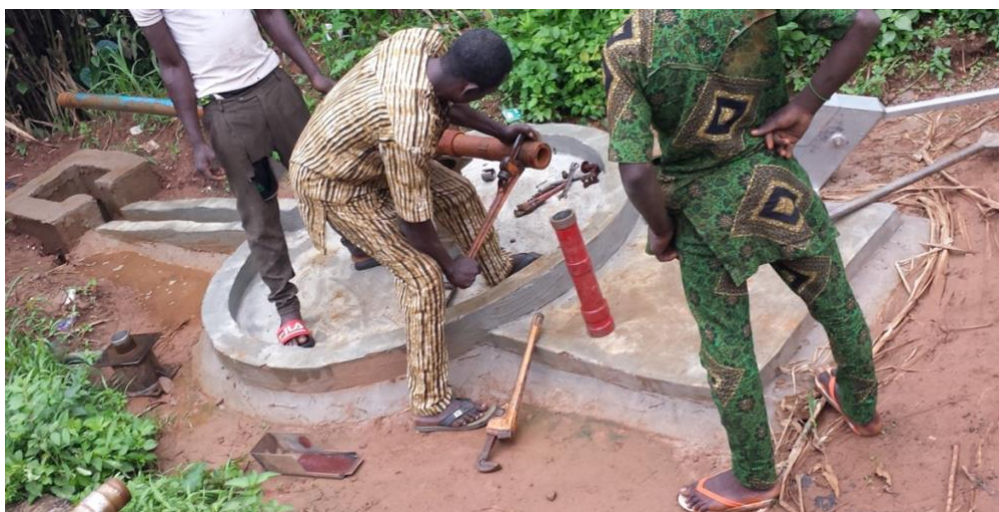
**FIGURE 9 CHANGING RUSTED CYLINDER IN OSUN STATE, NIGERIA**  
Source: Olajide Oyetunde.

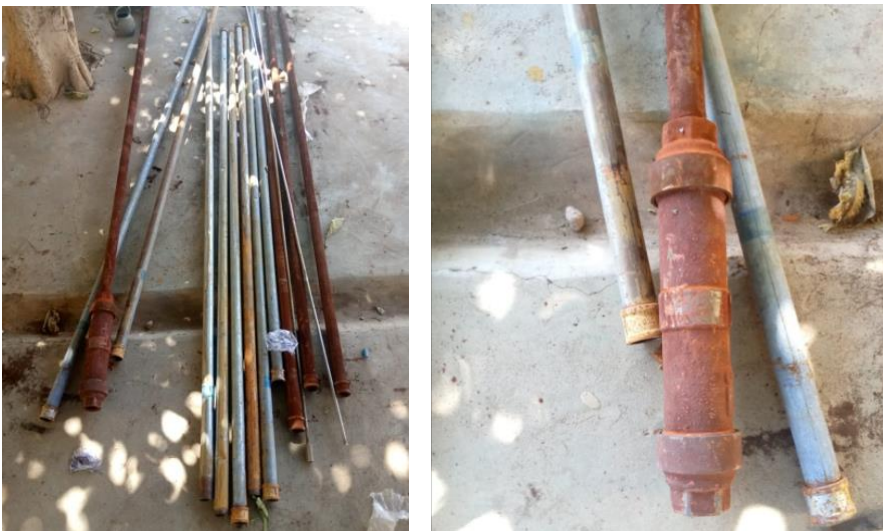
In the case illustrated in Figure A2.3., the handpump was initially installed in 2019 and rehabilitated in 2021. The photos indicate rapid corrosion or point to the installation of second-hand parts in the first place.

**FIGURE A2.3 PHOTOGRAPHIC EVIDENCE OF RAPID HANDPUMP CORROSION IN KATSINA STATE, NIGERIA**
