STOP THE ROT

Overview of handpump corrosion and maintenance challenges for a sustainable drinking water supply for rural populations in Cameroon - Case study of twenty pumps

Action-research on the corrosion and quality of handpump components in Sub-Saharan Africa

LINJOUOM NCHOUTPOUEN Abdou Aziz, PhD

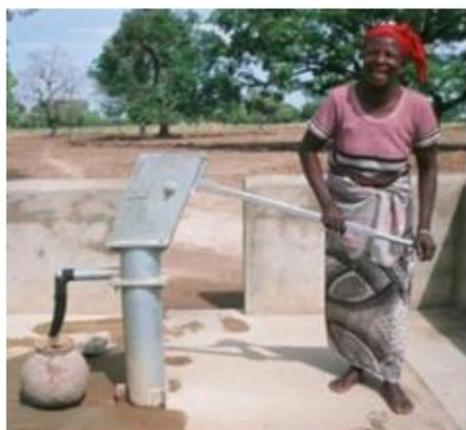
(a) India Mark II
Source : Karl Erpf.

The India Mark II pump is a robust conventional lever action handpump, designed for heavy-duty use, each pump can serve a community of about 300 people. The maximum recommended lift is 50 m. This is a public domain pump that meets the technical specifications of Skat Foundation and RWSN (2007b) and the Bureau of Indian Standards (BIS, 2004). Its installation and maintenance require special skills and it is not considered suitable for maintenance at the village level.

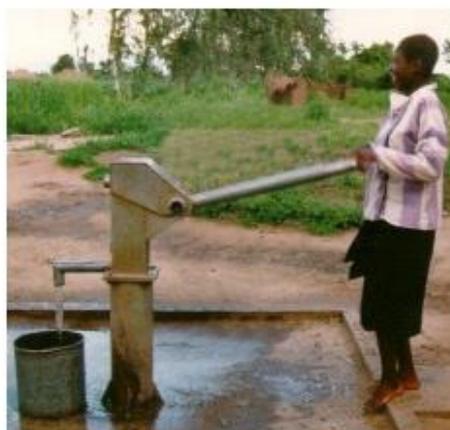
(b) Afridev
Source : Karl Erpf.

The Afridev Pump is a conventional lever action handpump. It is designed for heavy-duty use, each pump can also serve a community of about 300 people. The maximum recommended lift is 45 m. The Afridev pump is a public domain pump that meets the technical specifications of Skat and RWSN (2007a). It was designed in such a way that it could be maintained by the community itself, without outside intervention.

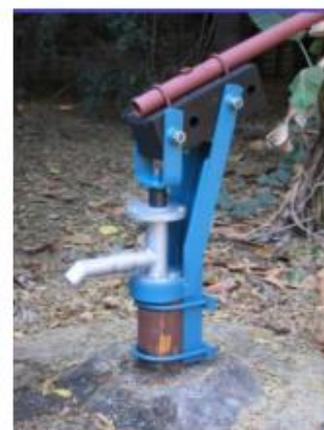
(c) Zimbabwe Bush Pump
Source : Peter Morgan.

The Bush Pump is a robust conventional lever action handpump, developed in Zimbabwe and meets the Zimbabwean standards (Government of Zimbabwe, 2013). It is designed for heavy-duty use, and each pump can serve a community of about 300 people. There are three different cylinders available, the smallest extending the reach to a maximum recommended lift of 80 m. The Bush Pump requires special skills for installation and maintenance.

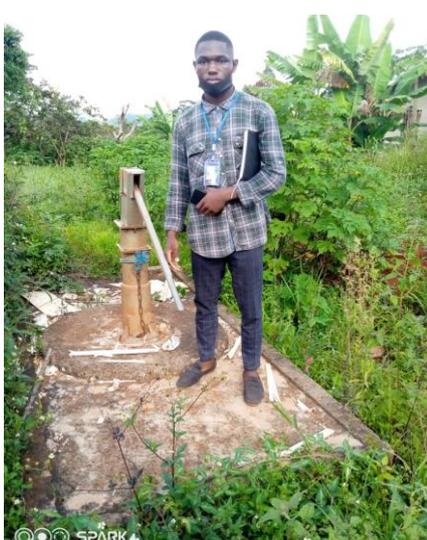
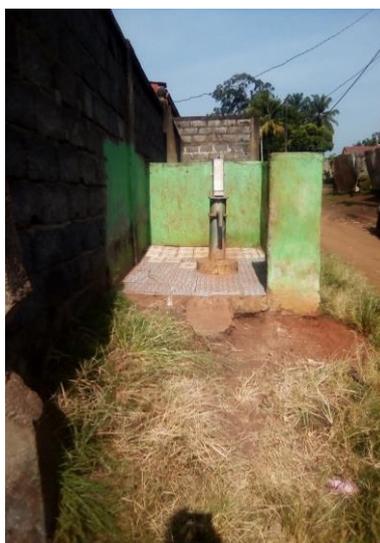
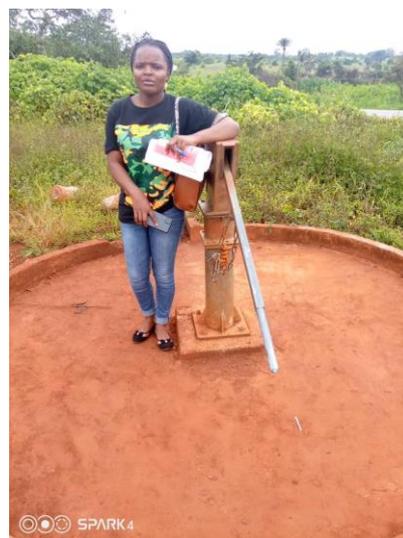
ILLUSTRATION 1 : PUMPS ABANDONED A FEW MONTHS AFTER INSTALLATION.

Rainatou, a 38-year-old housewife, who has lived in the "Petit Paris" neighbourhood for a long time, was lucky enough to have a borehole drilled in front of her home in July 2021 by a charity organization. This neighbourhood owes its name to its proximity to the improved quality of housing here. This, however, is not the case for access to water or its quality. During the survey, this borehole had been down for 4 months (Illustration 1 in the middle), it only worked from July to August 2021. They say

here that even when this water point was working, it barely gave 50 liters/day for a population of at least 700 people in this neighborhood. Moreover, the color of the water puzzled more than one person. The population here is ready to contribute to the rehabilitation of this water point despite the lack of initiatives. In the meantime, like the rest of the population, she has resorted to the public CAMWATER system, from which the neighboring house benefits and which flows sporadically (about 2 days/week), and mainly to a marsh located about 700 meters from her home, which flows continuously and for which she does not have to pay.

Illustration 1 on the left is a borehole with an handpump that is 5 years old. According to the population, the water that comes out of this pump has had a rusty smell and a reddish color since the installation of this pump in 2016. It had been out of commission for 8 months and was chained up when the study team passed by. No real initiative has been taken for its rehabilitation. It's the same for the borehole on the right.

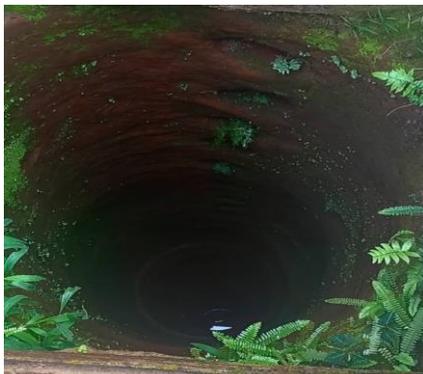
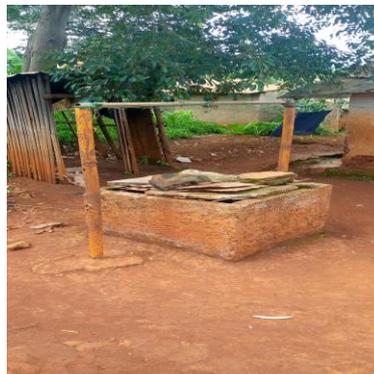
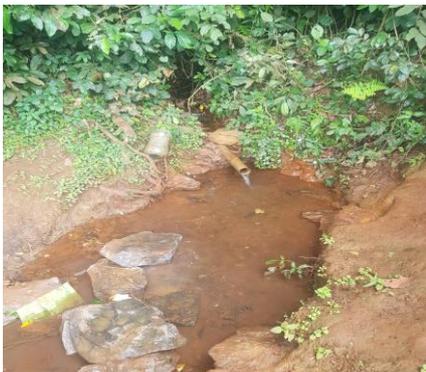
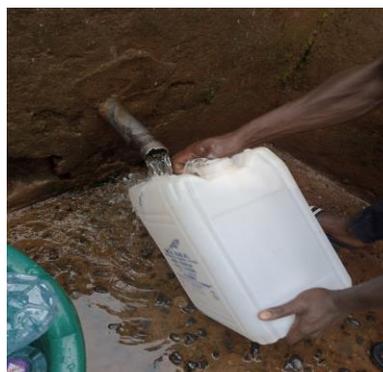
ILLUSTRATION 2 : ALTERNATIVE SOURCES OF WATER SUPPLY WHEN THERE ARE NO FUNCTIONING PUMPS.

The testimonies of the population mention the abandonment of these water points for other alternative sources (traditional spring wells, marshes, etc.) as presented in *Illustration 2* or simply the nearby handpumps that work. Since CAMWATER is not available here.

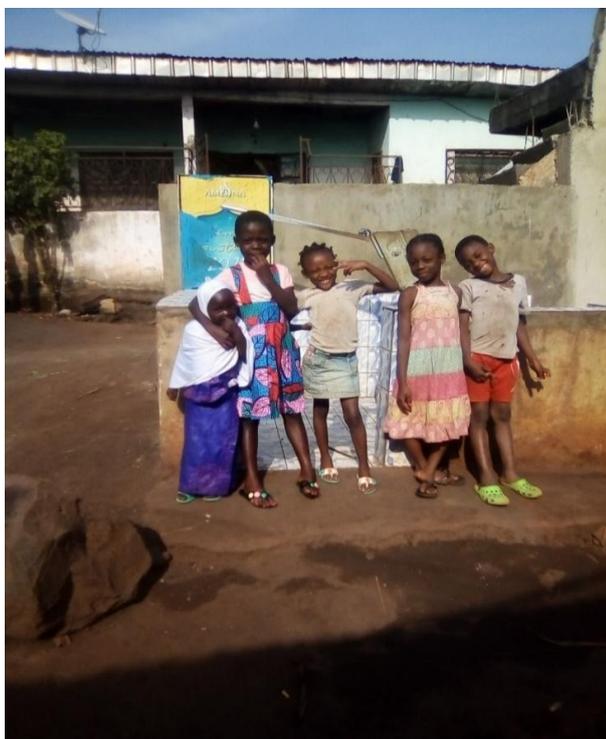
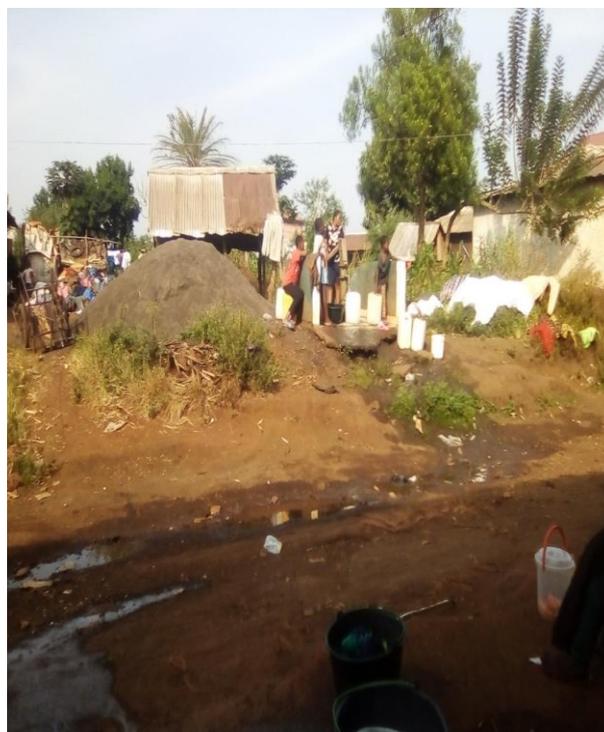
The first image (*Illustration 3* on the left) is a borehole equipped with a handpump provided by a charitable organization. Between March 2021 and December 2021 (at the time of the study visit) there were three (03) breakdowns. respectively due to a broken chain and a loose bolt on the inside of the device, because children had been abusing the pump. The only drawback here is the water, which she said was "*a little salty*". However, people prefer it over spring water. When the study team passed by,

it was blocked with a padlock, which is why these children who were looking for water were waiting. It must be said that it was in order to avoid abuse of the structure that this was put in place.

ILLUSTRATION 3 : CHILDREN LINE UP IN FRONT OF A PUMP THAT IS BARELY RUNNING DUE TO A LACK OF MAINTENANCE.

In fact, they leave the pump open from 8am-10am and 4pm-7pm depending on the number of people around the water point. In the event of a breakdown, any kind-hearted soul in the neighborhood can help out and be reimbursed for the costs they have incurred. The cost of repairs incurred during the last breakdown was around 75,000 CFA francs (150 USD). Each household usually contributes up to 200, 500 or 1000 CFA francs depending on the breakdown.

The next borehole (Illustration 3 on the right) is three years old. The problems encountered are respectively:

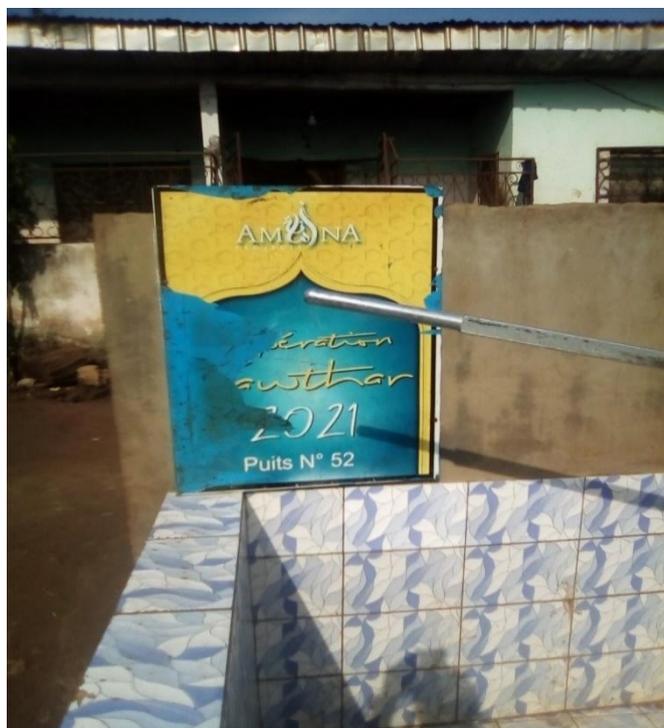
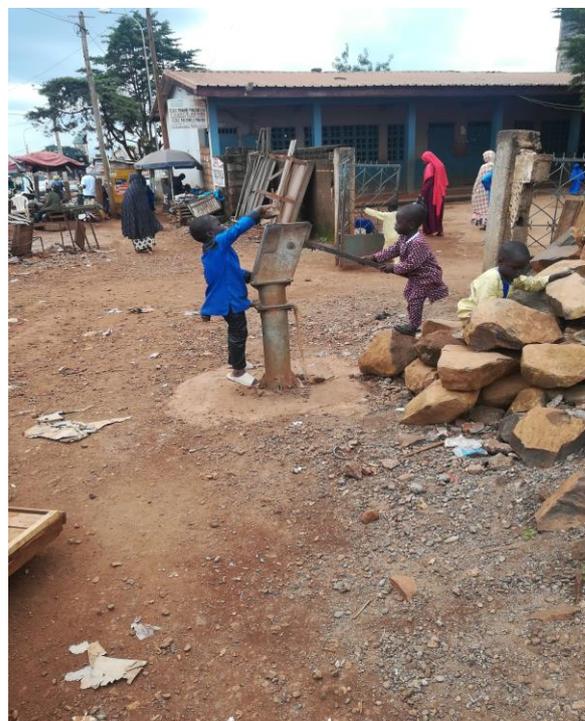
corrosion phenomenon, multiple breakdowns and maintenance concerns (Image on the right, Illustration 4).

ILLUSTRATION 4 : EXAMPLE OF THE EVER-INCREASING NUMBER OF HANDPUMPS IN CAMEROON AND THE MAINTENANCE CONCERNS.
