STOP THE ROT

Report III: Handpump standards, quality and supply chains with Zambia case study

ACTION RESEARCH ON HANDPUMP CORROSION AND COMPONENT QUALITY IN SUB-SAHARAN AFRICA

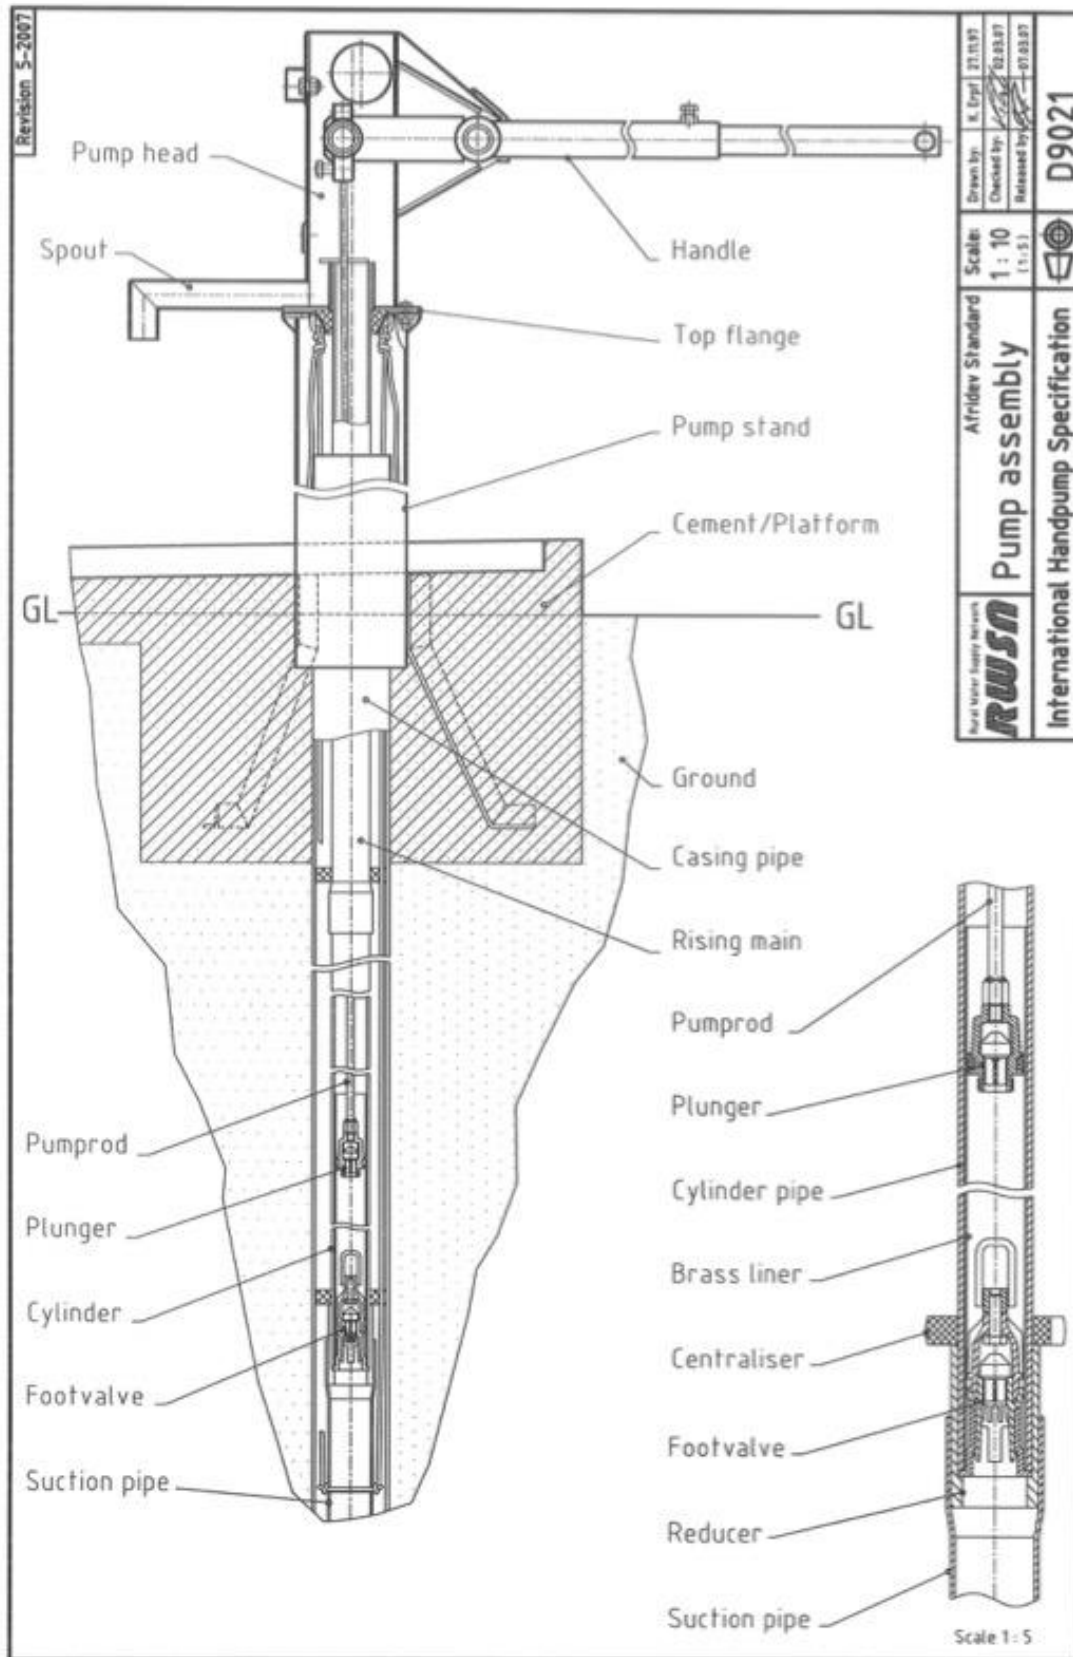
FIGURE 2 INDIA MARK II HANDPUMP COMPONENTS
Source: Skat/RWSN, 2007a.

Figures 1 and 2 will assist readers with the handpump component nomenclature that is used in this report.

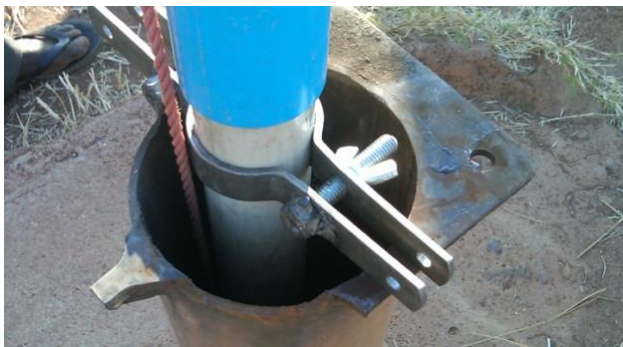
(a) Broken flanges on Afridev pump in Malawi
Source: Larry Bentley.

The photographs in Figure 3 illustrate examples of component quality problems.

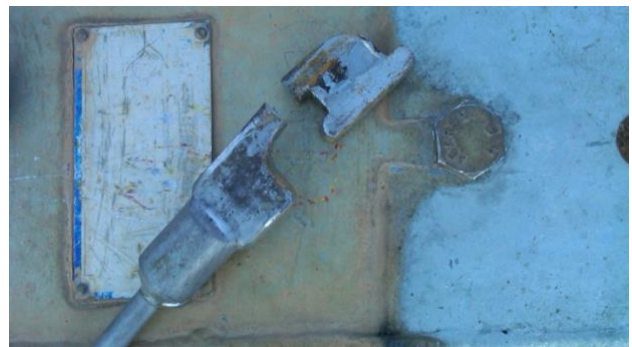
(b) Broken hook on Afridev pump in Malawi
Source: Larry Bentley.

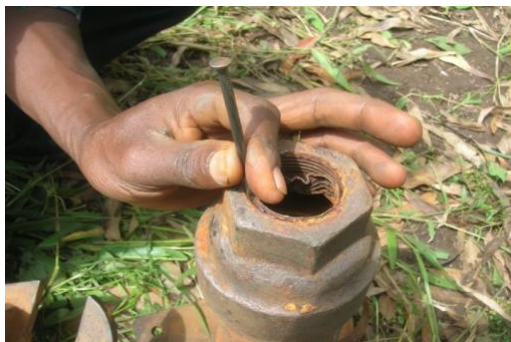
(c) Corroded pipe snapped off India Mark II cylinder in Uganda (old pipe threads being carefully peeled out to salvage cylinder)
Source: Larry Bentley.

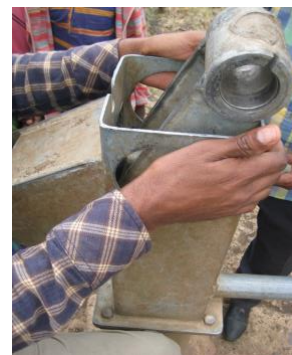
(d) Broken handle on Afridev pump in Malawi
Source: Larry Bentley.

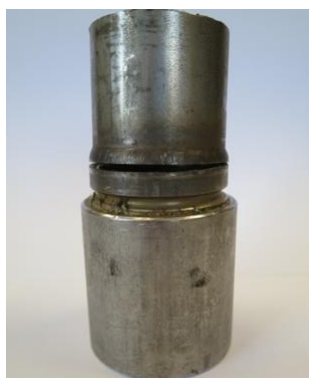
(e) Weld failure in riser pipe
Source: Tony Beers.

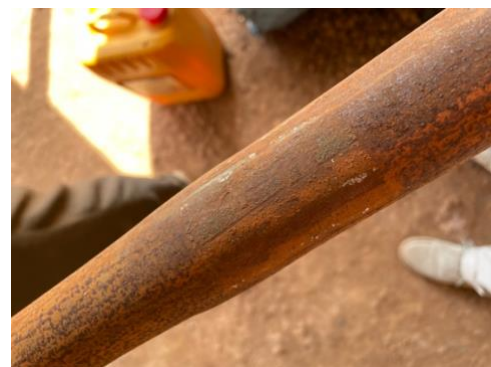
(f) Squashed pipe from lifting (most likely not correct grade)
Source: Richard Carter.

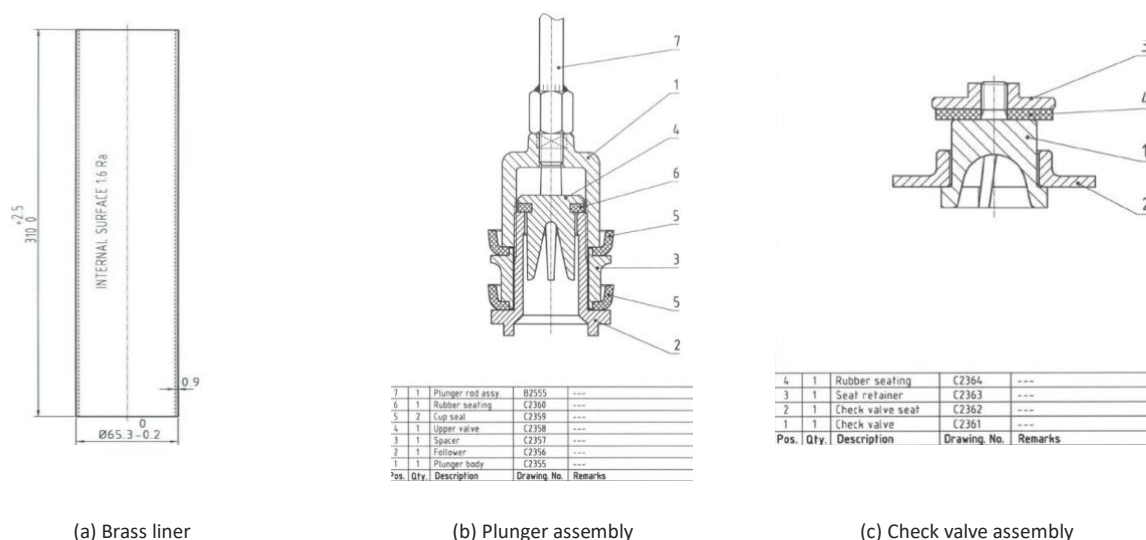
FIGURE 5 BRASS COMPONENTS OF INDIA MARK HANDPUMP CYLINDER ASSEMBLY BRASS

Recent research by Fisher et al. (2021) on pumped groundwater found a correlation between lead concentration in brass components and levels of lead in the water, although it has been pointed out that with an R² value of 0.66, the correlation may be overestimated (Anon, 2022). The study found very high lead fractions (14.8–52.9%) in all 15 brass foot valves sampled, thus shining a spotlight on handpump components made out of brass and bronze.¹⁶ Brass components of the India Mark handpumps are found within the cylinder assembly and comprise the brass liner, plunger body, follower, spacer, upper valve, follower, check valve, check valve seat and seat retainer (Figure 5).

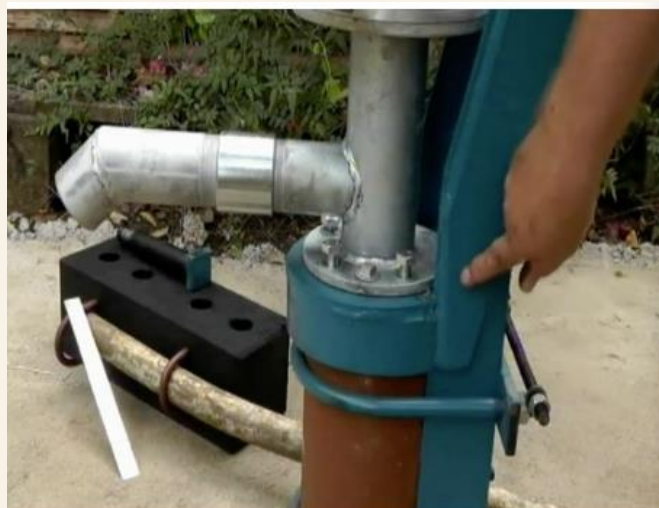
SCREEN SHOT OF VIDEO EXPLAINING BUSH PUMP COMPONENTS AND INSTALLATION

The videos explain what the different components are called and what they do, how the pump works properly, alignment of components (including use of templates, spirit level and set square), the rationale for certain design features, checking that components are properly made and essential maintenance of the headworks. The type and dimensions of components are given verbally, with use of a ruler to illustrate the components in question. In addition, the installation is explained clearly, including what will go wrong if dimensions are not correct or if components are misaligned (RWSN, n.d.(b)).

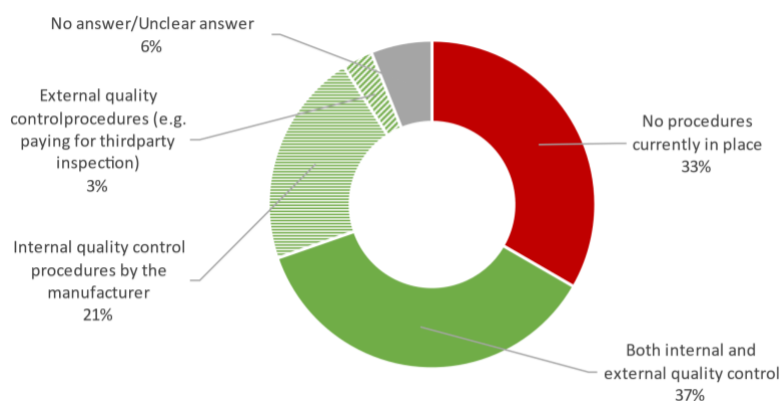
FIGURE 8 ORGANISATIONAL PROCEDURES FOR CHECKING HANDPUMP MANUFACTURING SPECIFICATIONS

- Of the 33 responses by those who buy handpumps directly, there are a diversity of practices (Figure 8), with 33% of respondents having no procedures in place to check that the pumps have been manufactured according to design specifications.
- Of the 25 respondents that buy handpumps as part of a borehole drilling package, only 36% stated that they inspect the pump before and after installation, while 48% only inspect the pump before installation and 12% only inspect it after installation. Only one respondent did no inspection. Of the 25 respondents, 16 (64%) stated that they also rely on national quality control mechanisms.

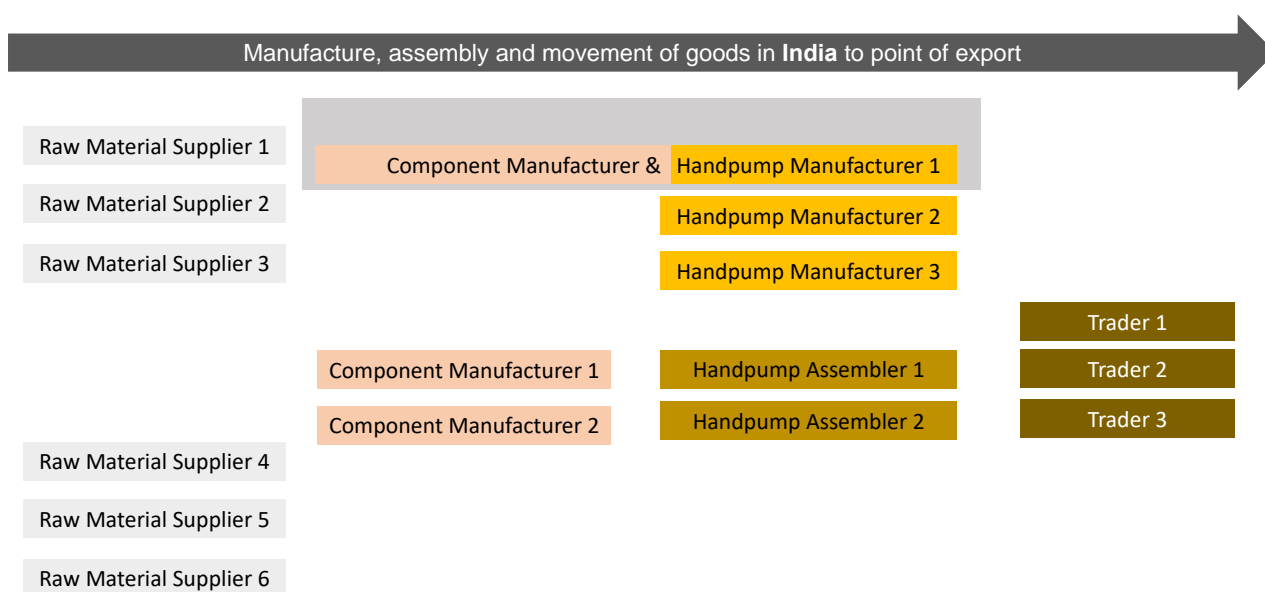
FIGURE 9: SCHEMATIC REPRESENTATION OF HANDPUMP SUPPLY CHAIN WITHIN INDIA FOR EXPORT

Taken together, Figures 9 and 10 illustrate there are at least five links within the supply chain (i.e. raw materials, handpump manufacture, in-country retailer, drilling contractor, community). However, there may be more. For example, the handpump may only be assembled in India by a supplier, with components manufactured elsewhere. Meanwhile, in *country X*, retailers may import from traders or buy from local stores, while handpump mechanics may install. Alternatively, a drilling contractor may import directly from India.

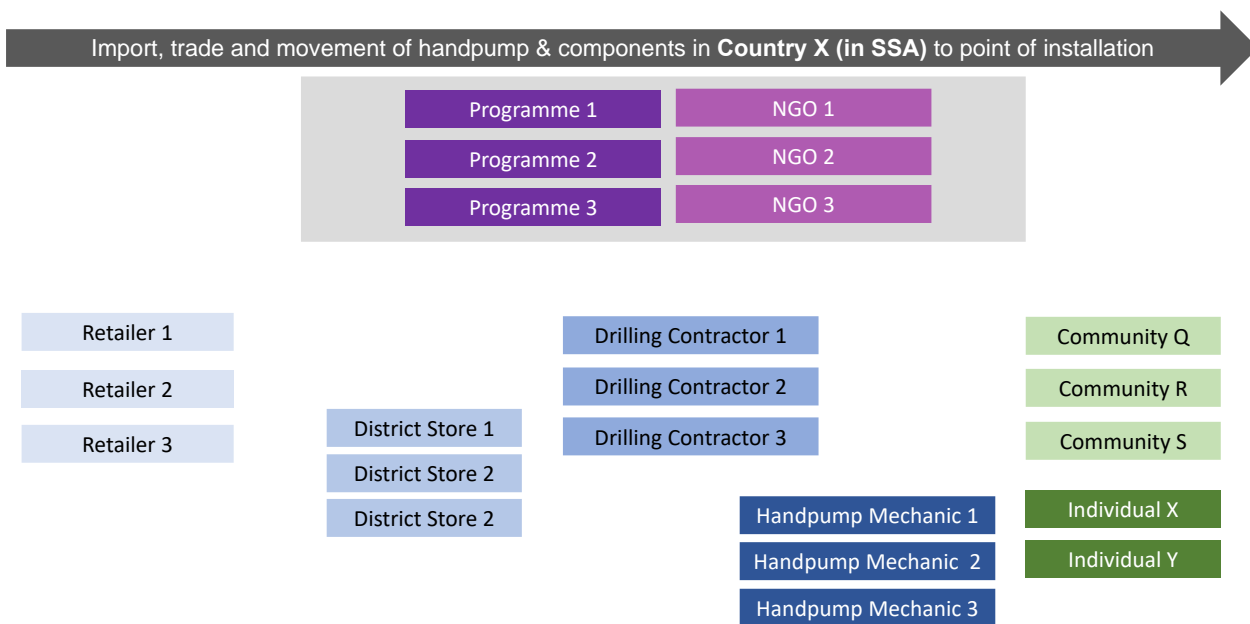
FIGURE 10: SCHEMATIC REPRESENTATION OF HANDPUMP SUPPLY CHAIN FROM IMPORT TO DISTRIBUTION IN COUNTRY X

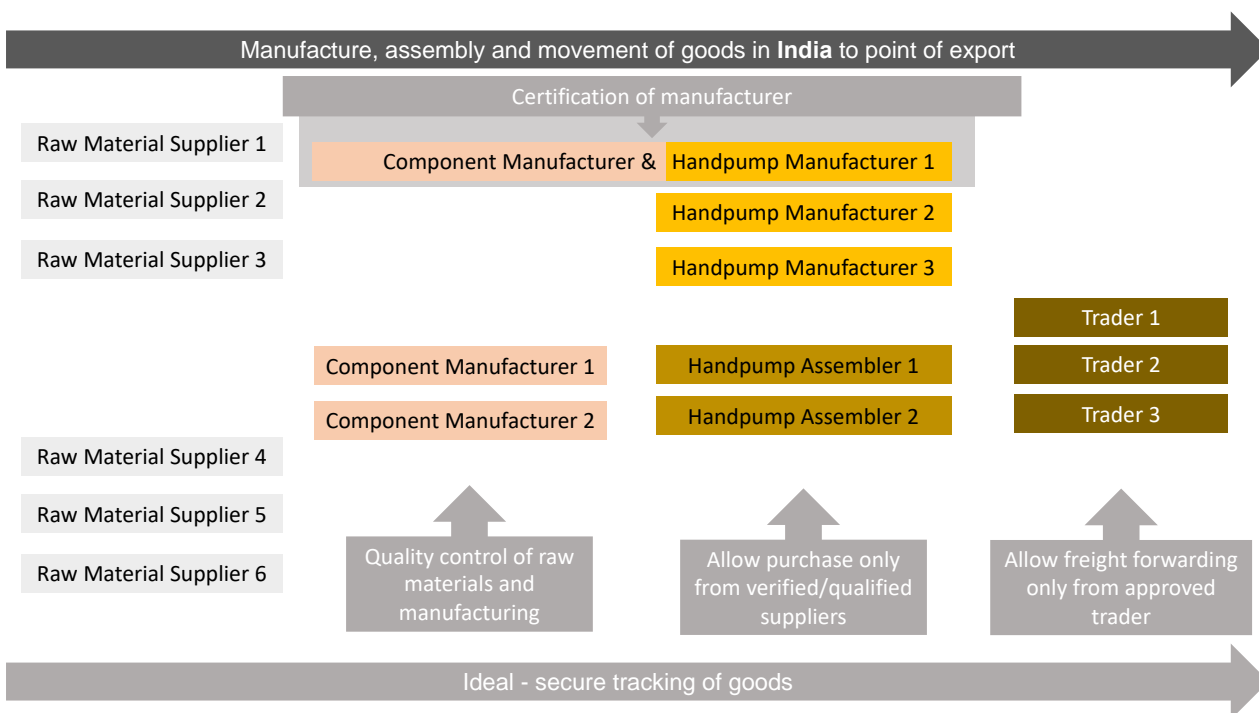
FIGURE 11: SCHEMATIC REPRESENTATION OF IDEAL HANDPUMP SUPPLY CHAIN – WITHIN INDIA TO EXPORT TO COUNTRY X

Figures 11 and 12 illustrate an ideal supply chain, which has quality assurance mechanisms in place at the manufacturing stage and a secure tracking of the goods throughout. In such a scenario, assemblers would only be able to purchase from verified/qualified raw material suppliers and only approved traders would be allowed to undertake freight forwarding. In-country retailers or distributors would only be allowed to purchase from approved in-country traders. A warranty programme could also form part of the supply chain.

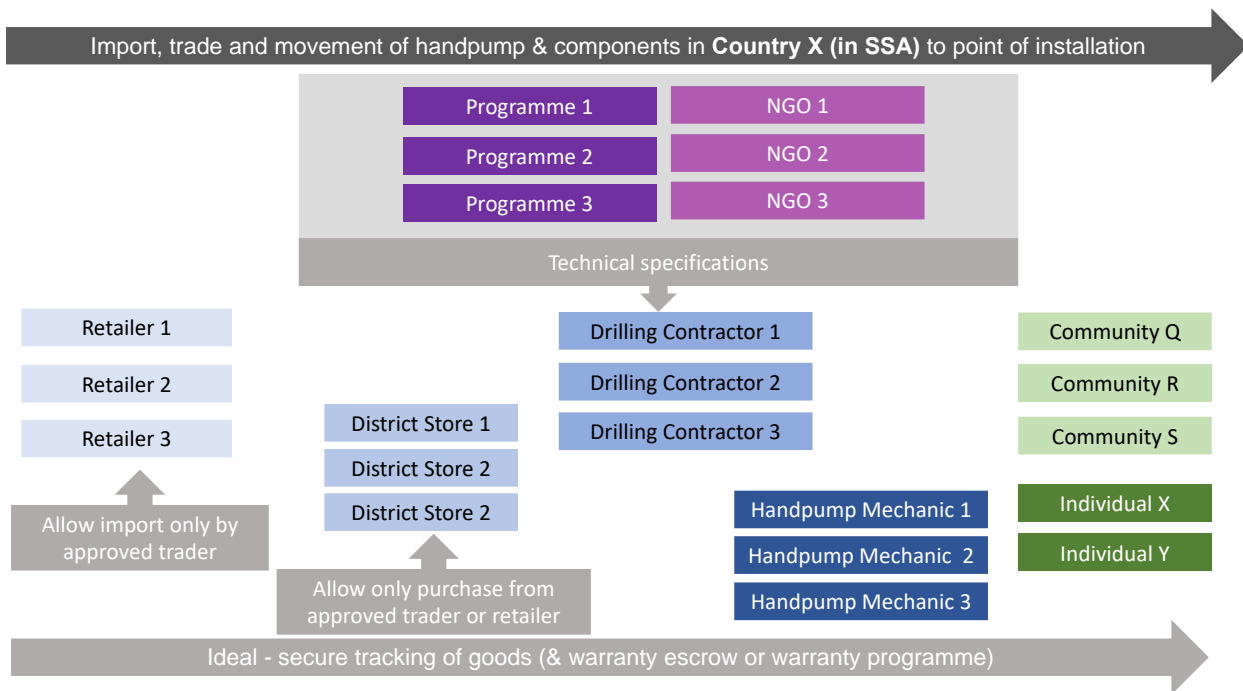
FIGURE 12: SCHEMATIC REPRESENTATION OF IDEAL HANDPUMP SUPPLY CHAIN – FROM IMPORT TO DISTRIBUTION IN COUNTRY X

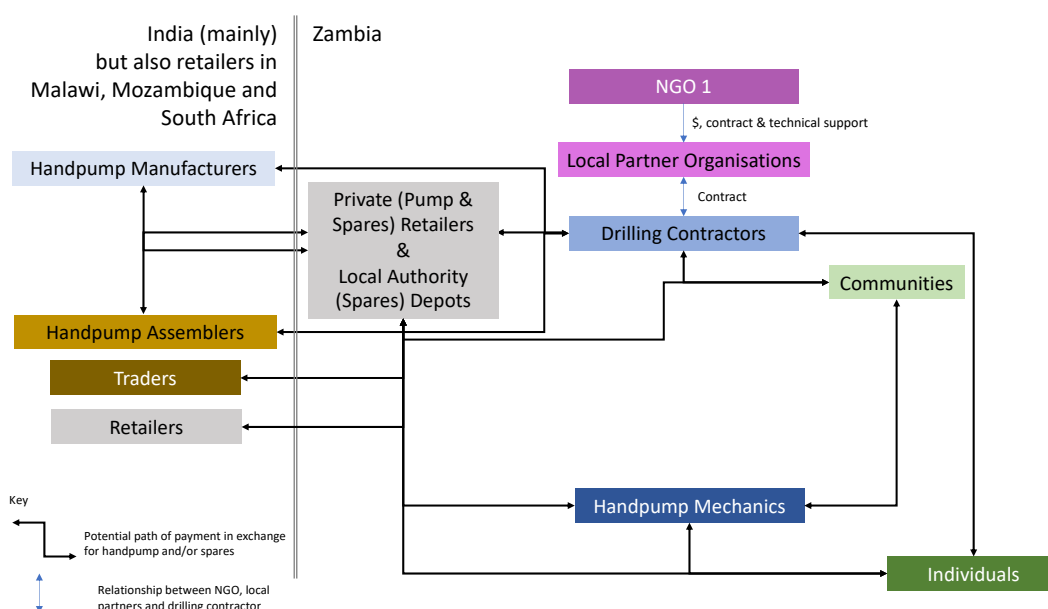
FIGURE 14: SIMPLIFIED REPRESENTATION OF HANDPUMP SUPPLY OPTIONS IN ZAMBIA

Figure 14 illustrates the supply chain options available for handpump and spares purchase in Zambia for an NGO or individual engaging a drilling contractor.

In the case of NGO-funded programmes, communities are donated a borehole and pump, which is generally bought and installed by the drilling contractor. Individuals tend to buy from a retailer or may rely on the drilling contractor. Individuals

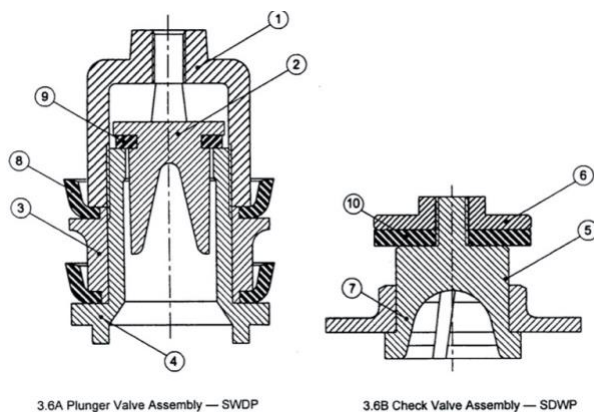
10	1	Check Valve Seating — Standard	Fig. 7.7	Nitrile Rubber	5.6 of Part 1
9	1	Upper Valve Seating	Fig. 7.6	Nitrile Rubber	5.6 of Part 1
8	2	Pump Bucket — Standard	Fig. 7.1	Nitrile Rubber	5.6 of Part 1
7	1	Check Valve Seat — Standard	Fig. 6.12	Bronze	Grade LTB2 of IS 318
6	1	Rubber Seat Retainer	Fig. 6.11	Bronze	Grade LTB2 of IS 318
5	1	Check Valve — Standard	Fig. 6.9	Bronze	Grade LTB2 of IS 318
4	1	Follower — SDWP	Fig. 6.6	Bronze	Grade LTB2 of IS 318
3	1	Bucket Spacer — Standard	Fig. 6.4	Bronze	Grade LTB2 of IS 318
2	1	Upper Valve	Fig. 6.3	Bronze	Grade LTB2 of IS 318
1	1	Plunger Yoke Body	Fig. 6.2	Bronze	Grade LTB2 of IS 318
Part No.	No. Off	Description	Reference	Material

NOTE — Check valve assembly to be punch locked on top at M10 joint at diametrically opposite two points after filing the two surfaces even.

- Part I General:
 - 5.4 Brass – ‘The brass tube used for cylinder lining shall conform to grade Cu Zn As of IS 407 and shall be temper annealed’.
 - 5.5 Bronze
 - ‘5.5.1 Bronze casting shall confirm to Grade LTB 2 of IS 318 with hardness 55 HB, *Min.* Alternatively Naval Brass conforming to IS 6912 can be used to forge the components’.
- Part 3 Handpump sub-assemblies:
 - Valve assemblies and materials (Figure A3.1)

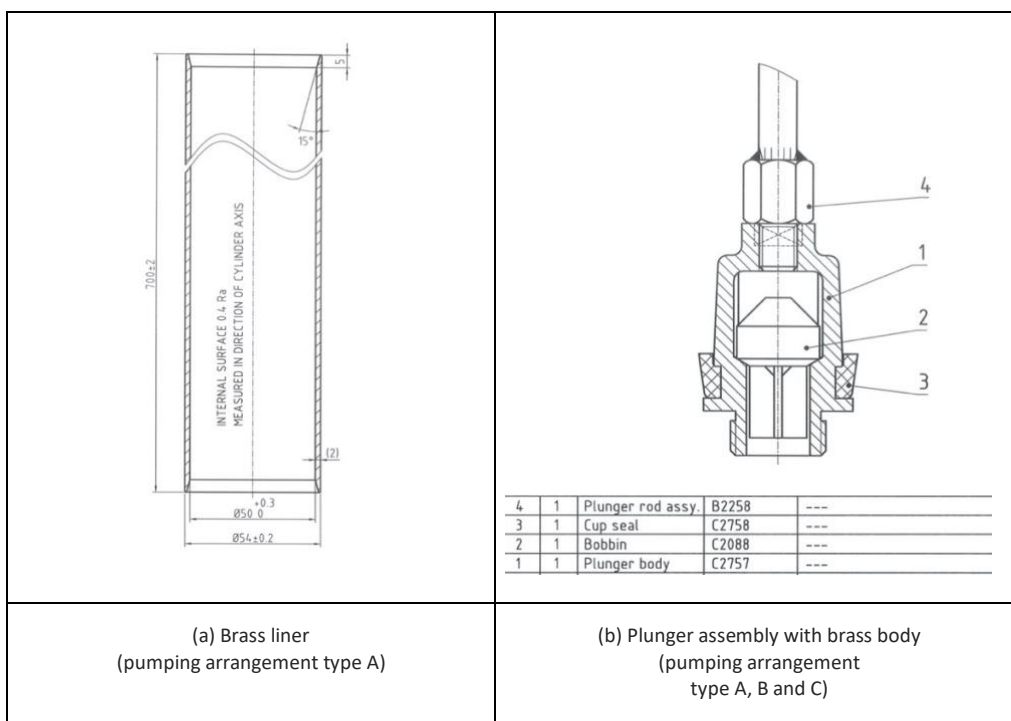
The three⁴¹ arrangements of the Afridev plunger and foot valve are:

- A. brass plunger with plastic foot valve
- B. brass threaded plunger, brass fishing connector and plastic foot valve
- C. brass threaded plunger with brass foot valve and brass foot valve receiver

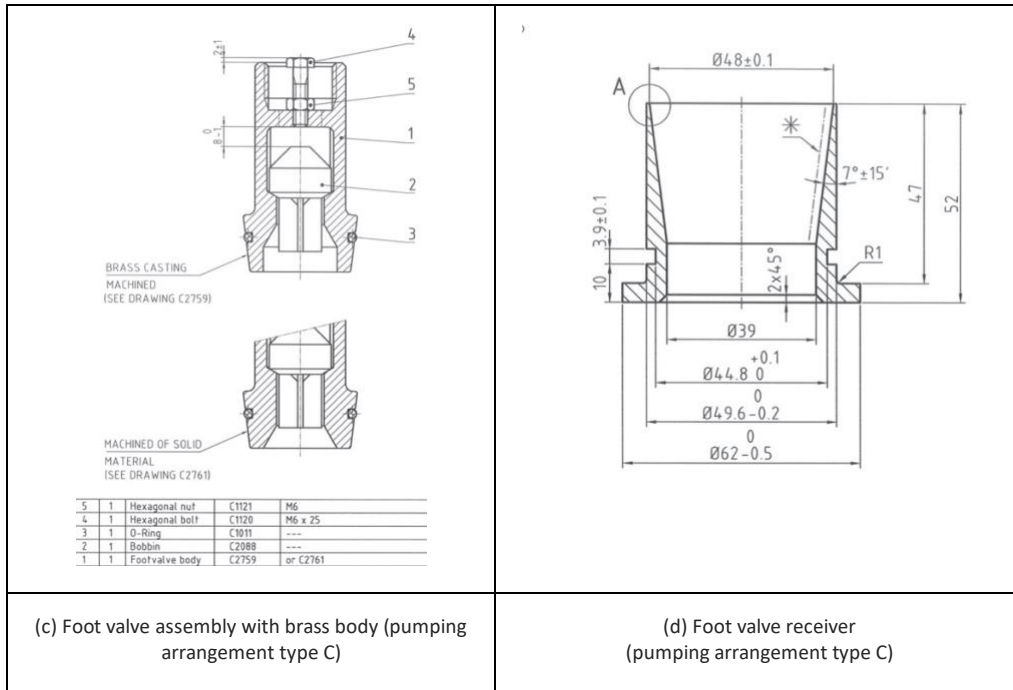
FIGURE A3.2 AFRIDEV CYLINDER ASSEMBLY WITH BRASS COMPONENTS
